# Runway Excursion Accident Data 2004-2008

PART 1: 2004 Data

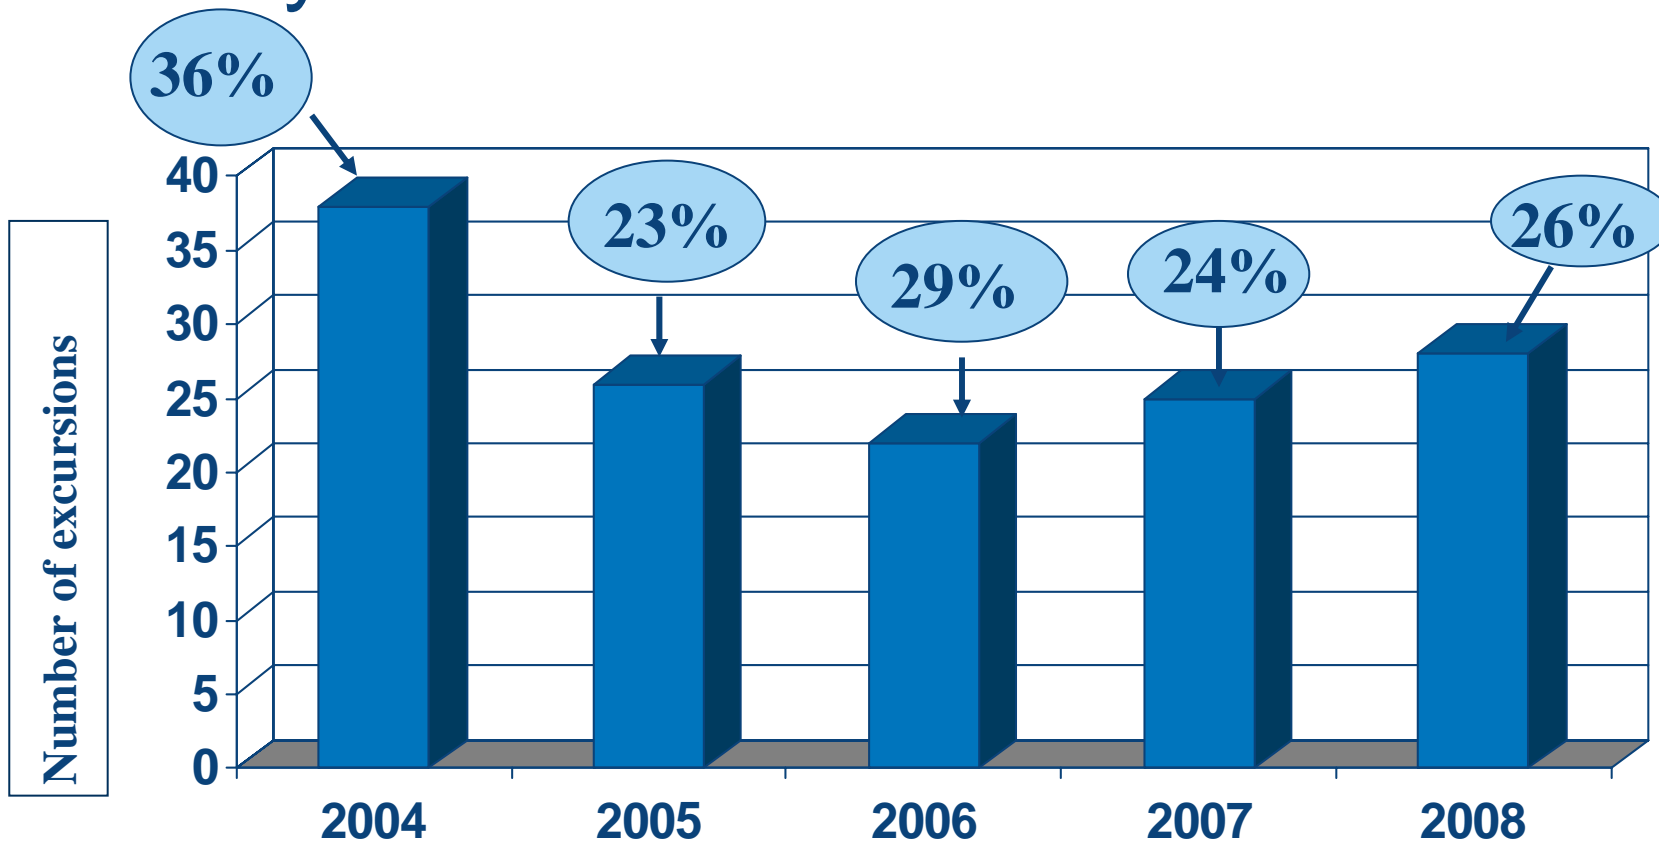
# Runway Excursions 2004 - 2008

The % is relative to the total number of accidents during that year
